R3-MYDAS

Mitigating Gearbox Failures in Wind Turbines through Remanufacturing and Material Innovation

October 2025

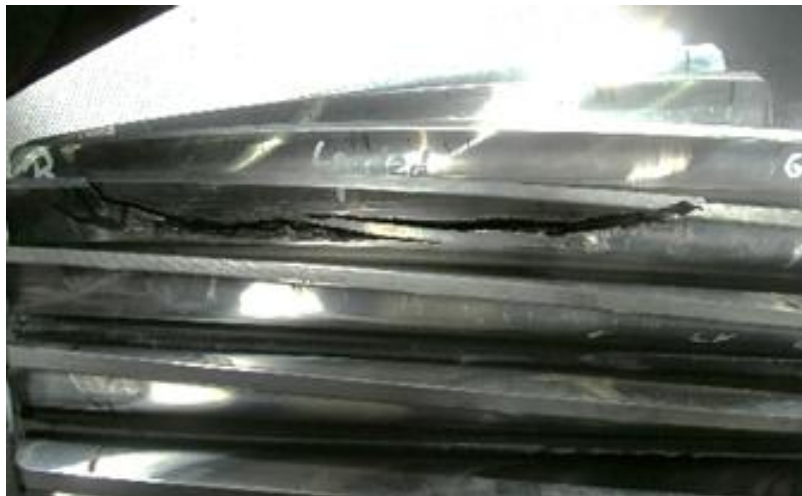
Figure 1: TFF failed tooth from a wind turbine gear in an overload test. Sudden single tooth breakage can happen after few thousand operative hours despite design lifetime being over 175 000h leading it to be considered as a premature failure. Root cause in this case was identified as subsurface inclusion bigger than allowed in material specification. [Flender Finland]

For high strength gear materials related failures, the risk assessment for TFF (Figure 1) and mitigation methods are needed and created. The most important part is testing gears to derive limit values for the fatigue strength

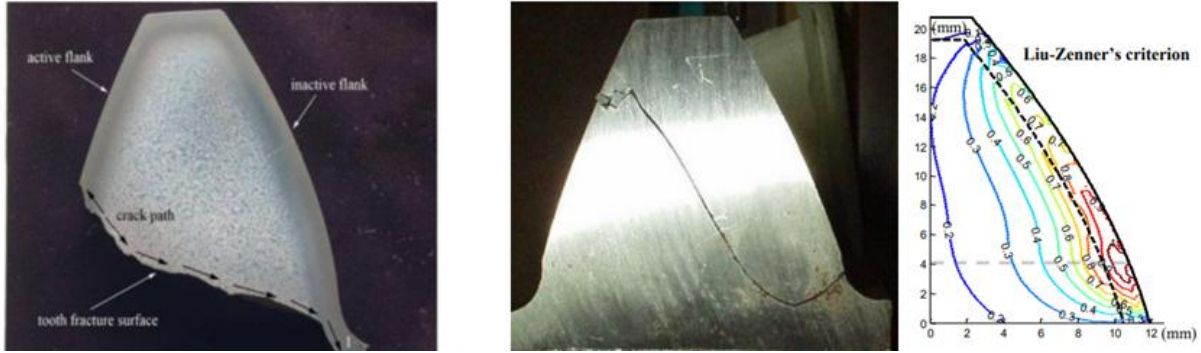
Figure 2: Simulations and practice show that the highest risk for TFF is below the case hardening layer. [2]

regarding TFF and to identify the main influences (gear size and geometry, material influences like grain size or cleanliness as well as influences from the alternative heat treatment methods). This practical data is used to have confidence for simulation models. Additive manufacturing can increase the risk of TFF, for example, if bonding layer cracking occurs at subsurface conditions (See figure 2). This needs to be validated before method is accepted.

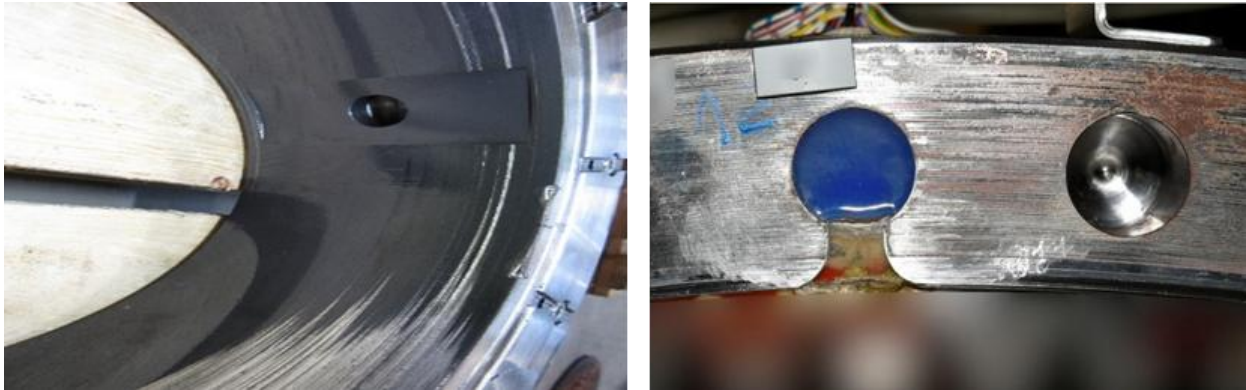
Figure 3: Left side asperity contacts and wear at journal bearing at testing component. Right side flange connection with initial fretting and wear from gear box level overload testing. [Flender Finland]

For Journal bearing and flange connection related failures (Figure 3), the risk assessment for the bonding layer strength is needed and the surface robustness validation against the application loads in the contacts. It is typical to have different kinds of cracks in the additive manufacturing processes. For example, cladding process can introduce several crack types as shown in Figure 4.

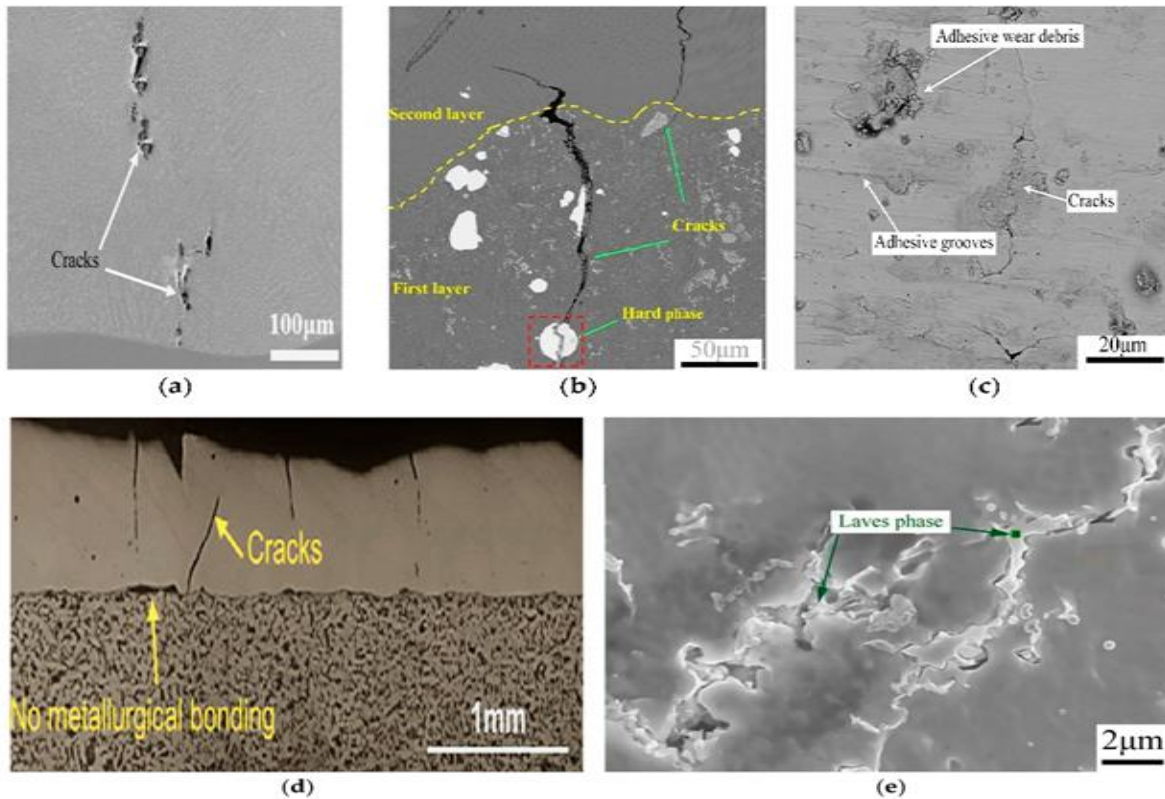
Figure 4: Different crack forms: (a) hot crack, (b) cold crack, (c) cladding crack, (d) interfacial matrix crack, and (e) Lap crack. [3]

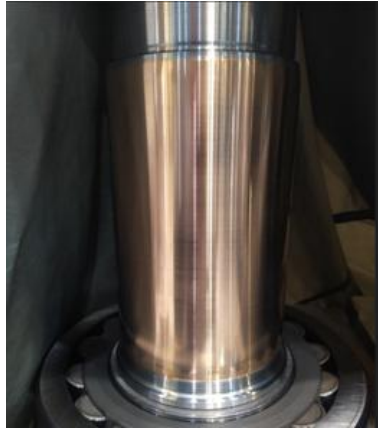
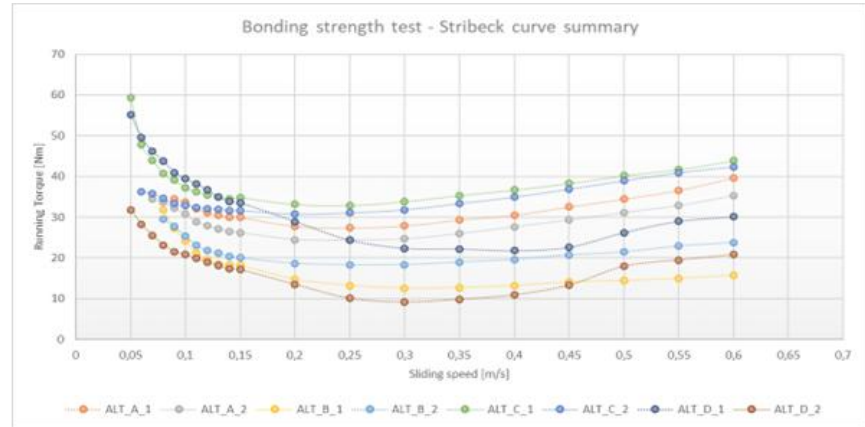
Figure 5: Laser clad journal bearing and variation between different alternatives.

Repair method to the initial axle material can also be confirmed. Figure 5 illustrates the Stribeck curve as one possible validation method for different laser clad sources and robustness against the asperity contact with results from different alternatives. Differences in performance can be observed from the summary as well.
