R3-MYDAS

Newsletter 4

R3-Mydas to exploit gearbox flange connections by state-of-the-art testing and remanufacturing technologies for high torque density journal bearing gearboxes

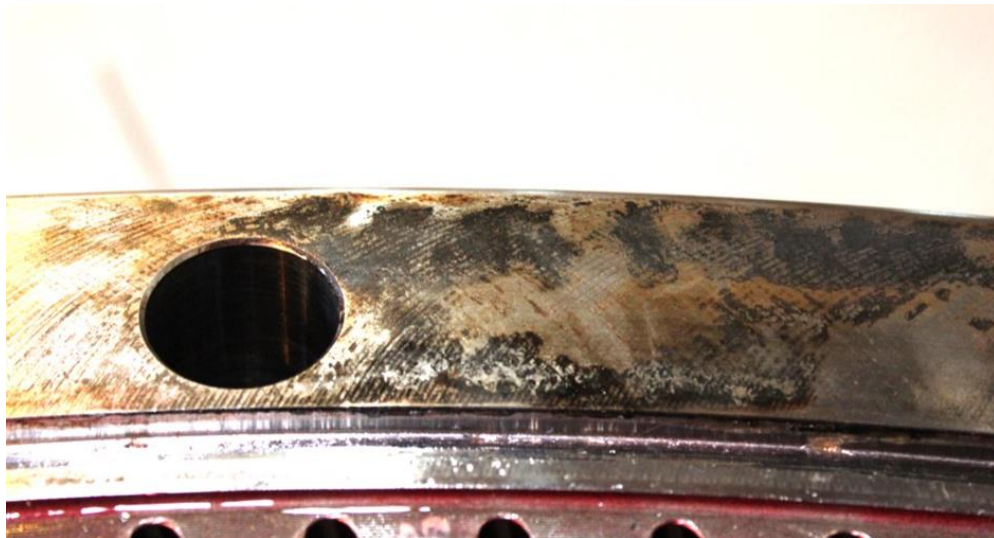
Figure 1. Example of fretting damage in bolted connection after part disassembly from field

Flange connection tester is design to reliably produce test parts with fretting corrosion, which is caused by micromovement between bolted support structures. Currently, design of the tester is proceeding to final version and procurement of assembly components has started. Tester will be a state-of-the-art configuration not available anywhere else on the market. It will allow testing of variable initial parameters, such as simulating changing loads, planet configurations, friction coefficients etc. Purpose of the testing is to isolate parameters causing fretting in flange connection and seek methods to improve reliability by prevention, redesign or remanufacturing. It is currently planned that commissioning will start in Q1/2025 and initial tests would be performed during Q2/2025. Moreover, investigation into remanufacturing possibilities of flange connection after fretting damage is ongoing.
